FABRICATION AND VERIFICATION TESTING OF ETM 30 CM DIAMETER ION THRUSTERS

FINAL REPORT

APRIL 1977

ION PHYSICS DEPARTMENT STAFF
HUGHES RESEARCH LABORATORIES
A DIVISION OF HUGHES AIRCRAFT COMPANY
3011 MALIBU CANYON ROAD
MALIBU, CALIFORNIA 90265

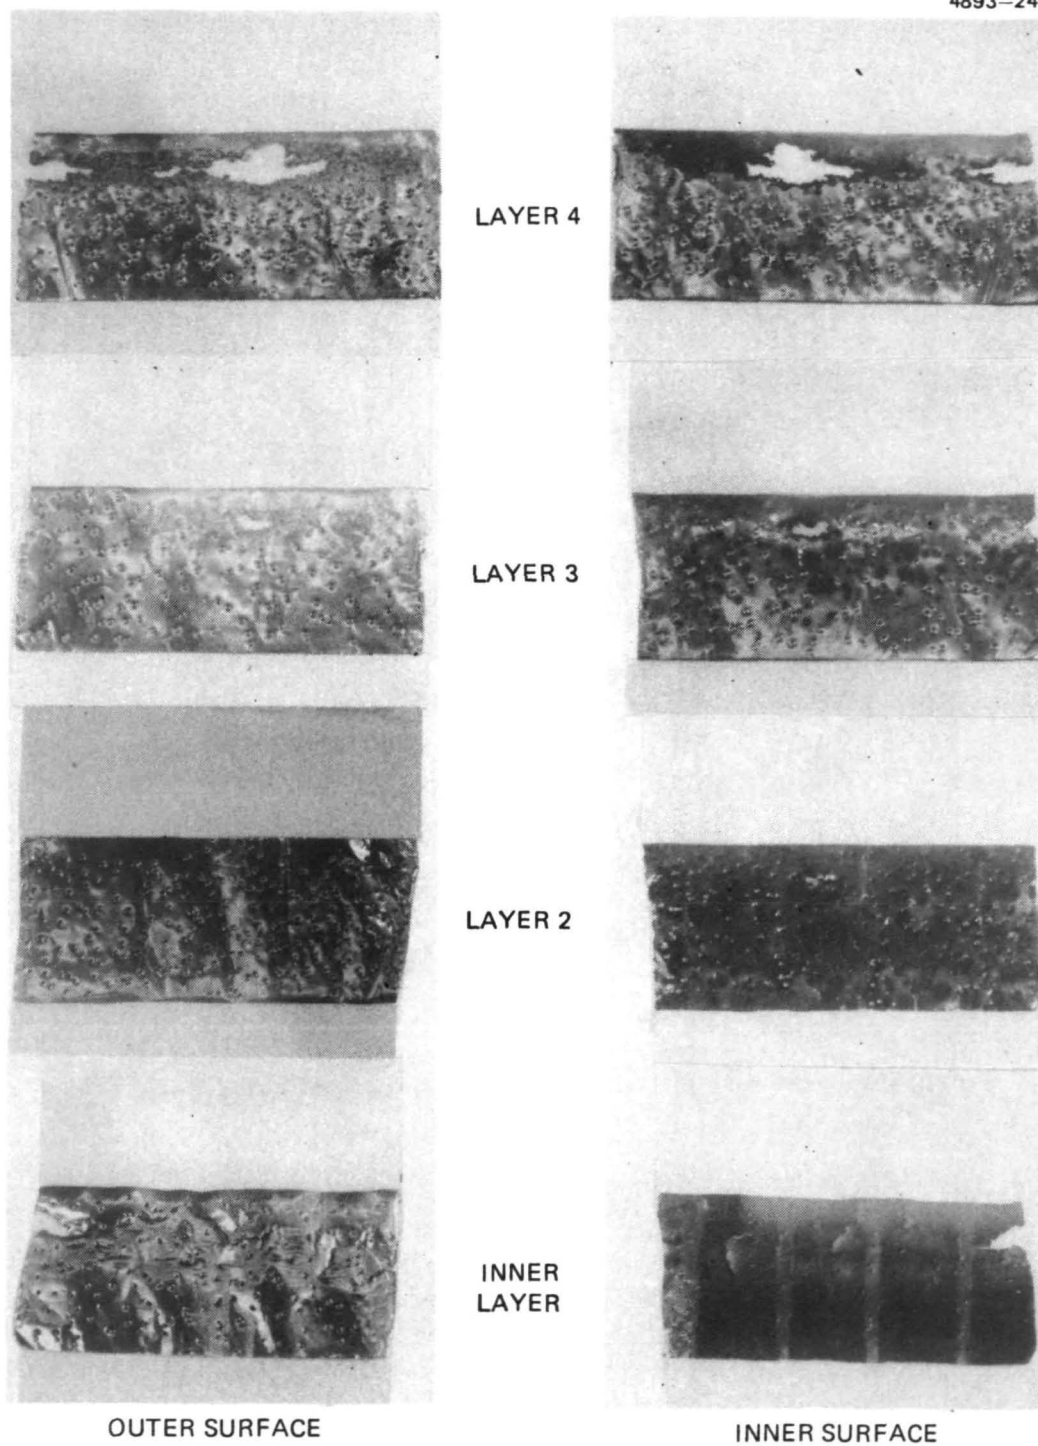
Figure A-118. Cathode heat shield after endurance test.
